Safety Alert

Hole in lid 1.5ml Tapered Tubes

Averting potential incidents

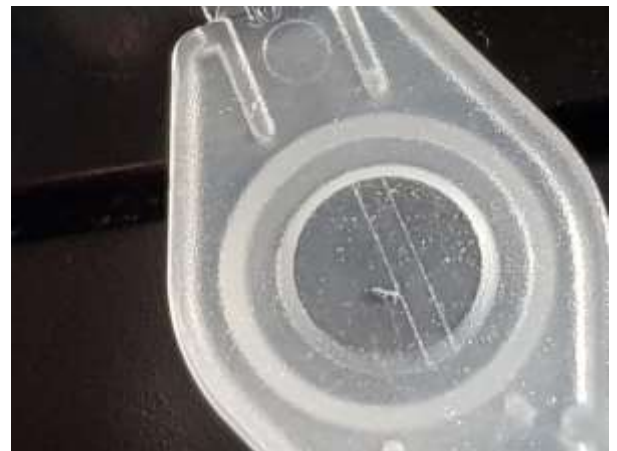
Image A

Thank you to the keen-eyed researcher who noticed and reported a small fault in some items in a batch of laboratory consumables. Many of the 1.5ml tapered tubes (image of tube) had a pin-head sized mark on a particular location of the lid (image A). A closer look at a larger mark showed that it was actually a hole (Image B). It is important to report faulty plant, equipment and laboratory items, not just to break the chain of events that could lead to an incident, but also to provide feedback to the manufacturer/supplier so that the problem can be sorted. This particular fault could result in the loss of contents (eg microorganism) with the subsequent contamination of equipment and exposure to personnel, or the ingress of substances. Thanks to the fact that the observation had been reported, communication was able to be sent to alert people to check their stock.
