# HS ALERT

<b>Incident /Hazard</b>	<b>UV Burn from Transilluminator</b>
<b>Incident</b>	<b>Prolonged exposure to UV light from transilluminator resulted in both eye and facial burns</b>
<b>Date</b>	<b>19/10/2012</b>

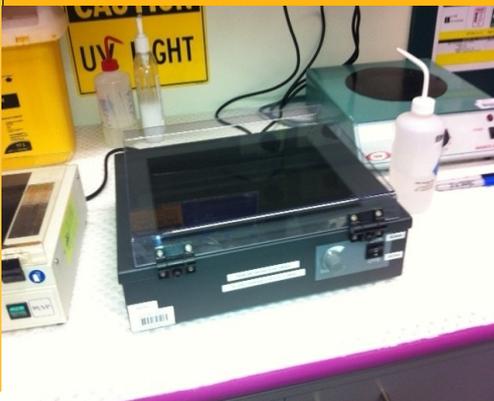
A lab worker received significant eye and skins burns from over-exposure to UV while working adjacent to a UV transilluminator.

On 19th October, two lab workers were using a transilluminator to view DNA/RNA that had been separated by electrophoresis. In addition they were cutting out the bands that form on an agarose gel during this process. Whilst viewing of the bands can be undertaken with the protector cover/shield in place, cutting up of the bands requires the shield to be up, to enable access for cutting. In such instances a UV rated protective face shield must be worn. However, on this day only one of the workers was wearing the appropriate face shield.

1. Ensure that all workers in the vicinity of the transilluminator are sufficiently aware of the hazard regardless of whether they are using the equipment or not.
2. Ensure a UV rated shield is installed around the equipment to protect workers who are working adjacent to the equipment particularly where the fixed shield cannot be used .
