# OHS ALERT

<b>Hazard</b>	Explosion within the hose and fittings connected to high pressure oxygen tanks
<b>Incident</b>	Significant head and face injuries which resulted in the loss of sight in both eyes, and multiple skull and facial fractures
<b>Date</b>	18/07/2011

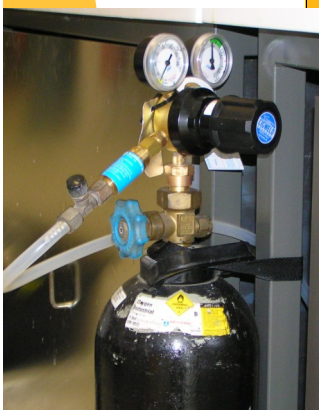
An explosion occurred within the hose and fittings connected to the high pressure oxygen tanks and they broke away from the tanks and struck a worker with considerable force on the face and head. He sustained significant injuries to his head and face, which resulted in the loss of sight in both eyes, and multiple skull and facial fractures.

It was found that the installed hose was designed primarily for hydraulics, and not designed for use with high-pressure oxygen.

1. Ensure hose fittings are certified for use and appropriate for the gases being used.
2. Undertake a risk assessment of all high pressure gas operations.
3. Ensure that changes to gas-lines or pipes are carried out by qualified gas fitters and in accordance with the safety instructions of the designer, manufacturer or supplier of the equipment.
