OHS ALERT!

Type of Incident	Explosion in an Autoclave and subsequent fire
Date Occurred	6 th October 2006
WHAT HAPPENED	<p>An explosion occurred in the autoclave of the biological waste contractor.</p> <p>The biological waste contractor picked up biological waste from UNSW on 6th October and took it to the waste processing centre at Unanderra.</p> <p>While decontaminating the biological waste an explosion occurred inside the autoclave. Upon removal of the waste from the autoclave it burst into flames.</p> <p>Early investigation indicates that glass vials with rubber diaphragms (GC or HPLC vial) containing chemical waste (probably a flammable liquid) were placed in the Biowaste bin. See attached Image 1 on page 2.</p> <p>The incident is currently being investigated by WorkCover and the EPA.</p> <p>The biological waste contractor is identifying the chemical found in some of the glass vials to try and determine its origin.</p>

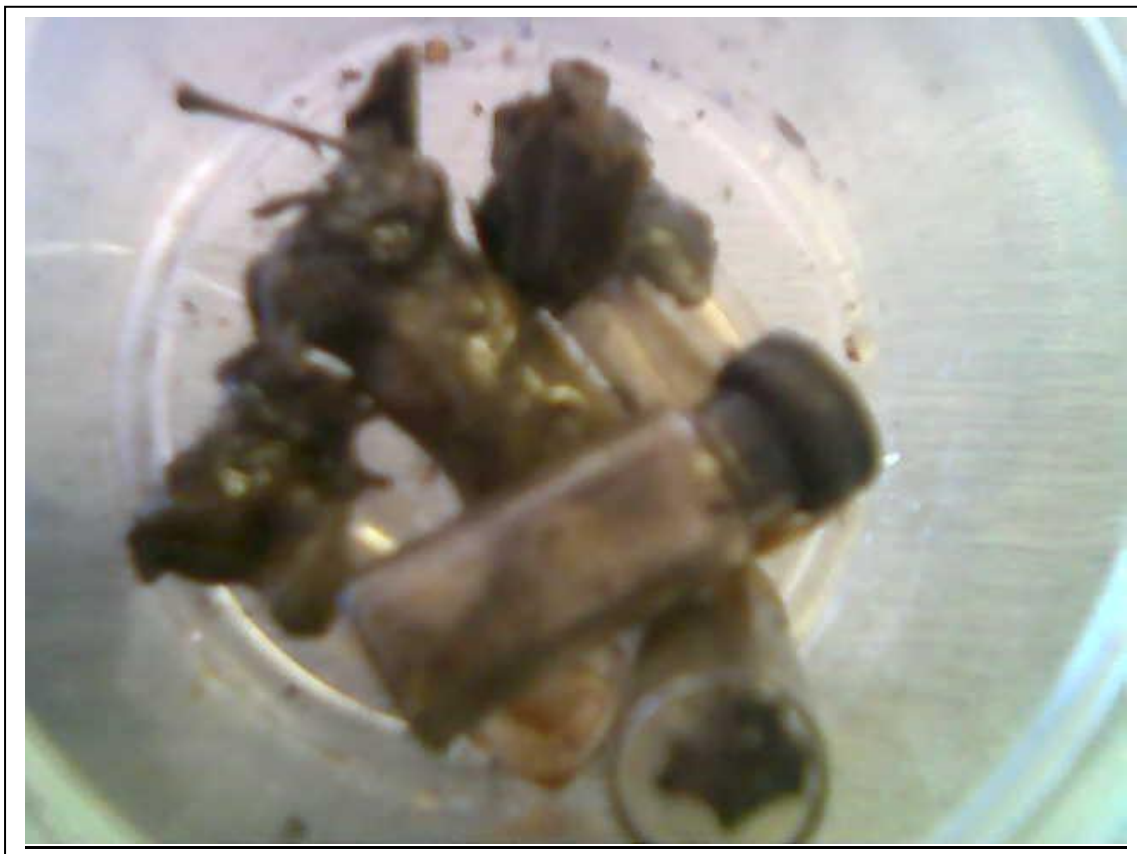
Image 1 - Some of the vials suspected of causing the incident.

WERE THERE ANY INJURIES	None reported at this time
Most Likely Cause	Incorrect disposal of chemical waste in the Biowaste bin.
Corrective Action	<ul style="list-style-type: none"> • All areas that generate biological waste are to review their waste disposal procedures to ensure waste segregation. • Ensure all staff and students are trained in biological waste and chemical waste disposal requirements. • UNSW to conduct random biological waste inspections.
