## Safety Alert July 2021

### Biosafety Cabinets: periodically check seals, fasteners and plugs

**A Biosafety Cabinet Class 2 (BSCII) was found to be leaking air from around the front sash.**

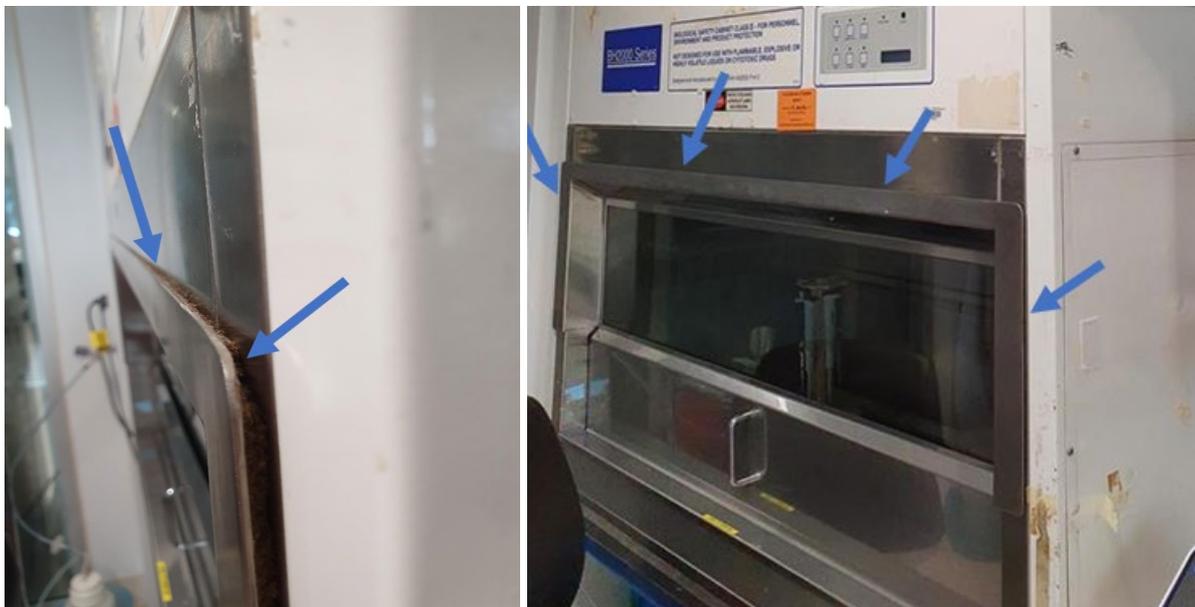
Following the repair of a BSCII, it was smoke tested by the repairer and smoke was clearly visible escaping from the space between the hinged sash housing and the body of the front of the cabinet. The cabinet had passed the annual test several months earlier but could have been leaking potentially contaminated air for some time, without the user realising.

An important seal was found to be perished beyond any ability to stop air escaping from the cabinet (see Photo 1). This seal is fitted around the perimeter of the closed housing of the fixed-height sash and is visible when the hinged sash assembly is opened for cleaning or repairs. Like all seals, they will perish over time and should be replaced, particularly when they form part of the safety features of the equipment.

*Photo 1: Arrows show the location of air leaks*

*Photo 2: Arrows show the location of the seal*

- Users should give a general inspection of the cabinet before use.
- Those doing routine cleaning of the cabinets should check moving parts and seals.
- If the cabinet is within service date and you have concerns about its performance, tell the Lab Manager & consider a retest or bringing forward the next scheduled test.
- If you come across an issue, check other cabinets of similar make, model, age as these may also be showing similar problems.
- If you are not confident that the testing company is delivering the required standard of testing and maintenance, escalate your concerns to the Lab Manager and to the testing agent.
